Technical Bulletin #56

To: Coulometrics Support Personnel
From: Engineering Dept.
Date: REV A. 3-01-04
Subject: Evaluation of Low response value during cell setup on a CM5014 Carbon Coulometer

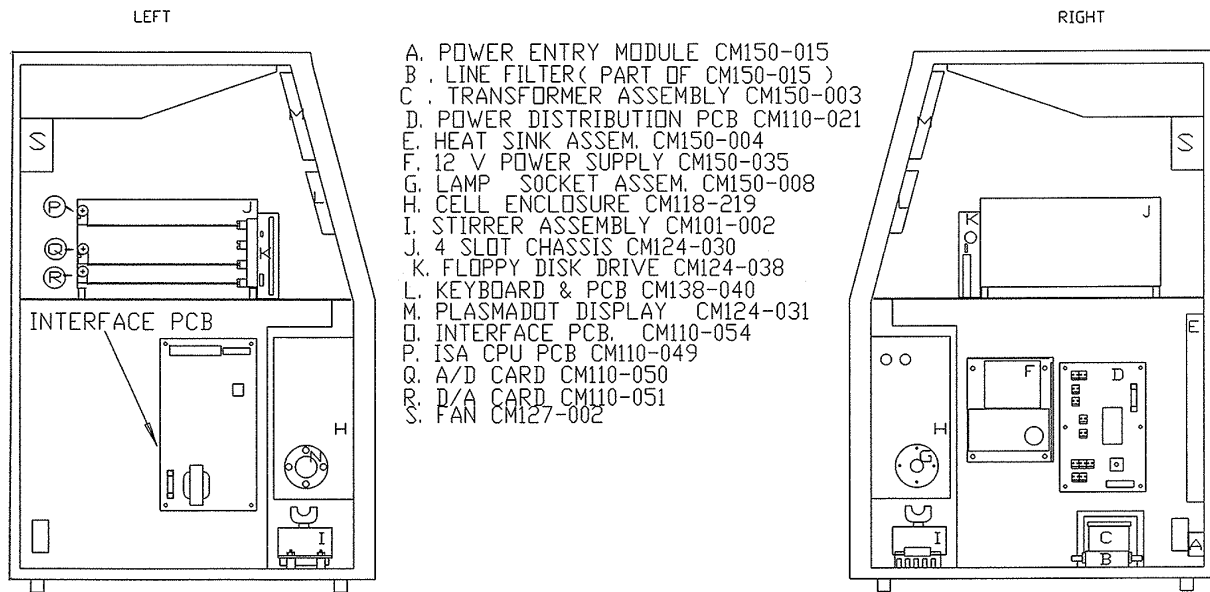
Figure 1
CM5014 SUBASSEMBLIES

To check and or adjust the lamp voltage, make sure there is no cell in the cell compartment. Turn the power off to the instrument and remove the left side panel. Locate the CM110-054 Interface board. See figure 1 item O. At this time it would be wise to also make sure all the connectors to the CM110-054 are plugged in (Figure 3). Especially JP3, the photodiode plug and JP2, the lamp plug. Reset the connectors by pushing on them . Attach a volt meter to TP1 (red) and TP2 (black)of the CM110-054 board (see CM110-054 figure 3 attached). Turn the instrument on. Measure the lamp voltage. If the lamp voltage is low adjust the potentiometer marked RP1 to increase the voltage. **Do not adjust the voltage above 2.5 VDC.**

If the %T is still low the next common source of this problem is the filter in the detector cell assembly has become clouded or the photo diode detector is defective See figure 1 item N for location of Detector assembly. This sometimes happens when the unit has been in service for some time. The filter, Item CM140-001 can be replaced by itself. The photo diode is CM140-002. Replacing however the complete photo diode sub-assembly(CM101-178) is better because it eliminates the need for field assembly and soldering. See figure 2 for exploded view of assembly.
