Technical Bulletin # 49

To: Coulometrics Support Personnel
From: Applications/Engineering Dept.
Date: February 2, 2004
Subject: Installing new CM115-008 Thermocouple in the CM5200.

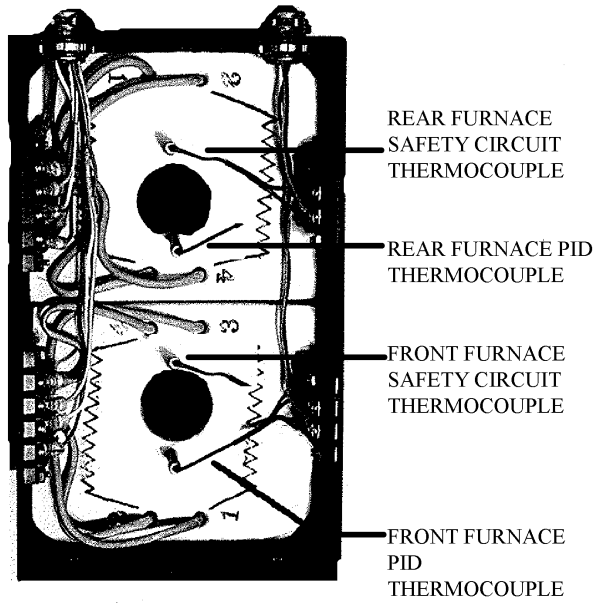
FIGURE 1. Heater Assembly with top cover removed.
FURNACE ASSEMBLY TOP VIEW

8. Locate the defective thermocouple. There are 4 TCs, One for the front Heater PID, one for the front heater over temp safety circuit, one for the rear heater PID and one for the rear heater safety circuit. The thermocouple that is defective will depend on which furnace has a problem. (See figure 1)
